Prepared for:
Spring Creek Condominiums
Florissant, Missouri
Project No. 5555-44.5

February 3, 2017
By Kipcon Great Lakes, LLC

Executive Summary

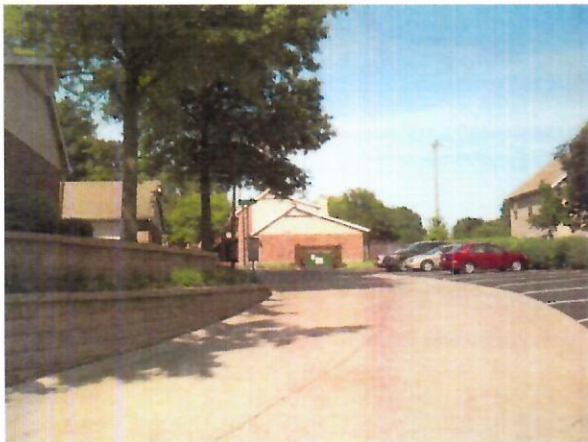
Crack in Center of section of Road

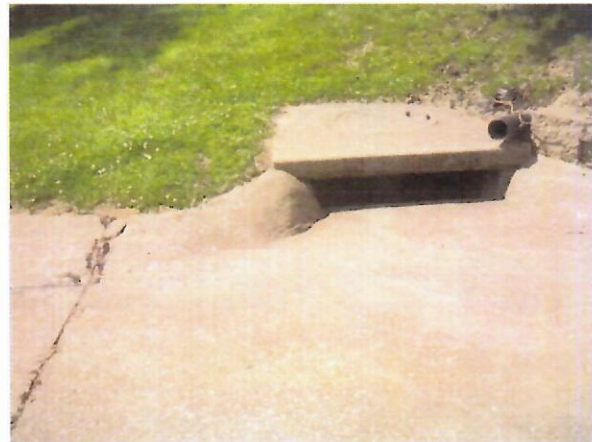
Storm Sewer crack at expansion joint

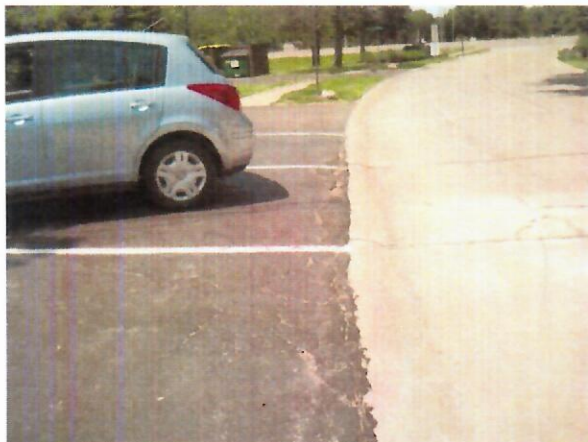
Road cracks and Auxiliary parking raveling at junction

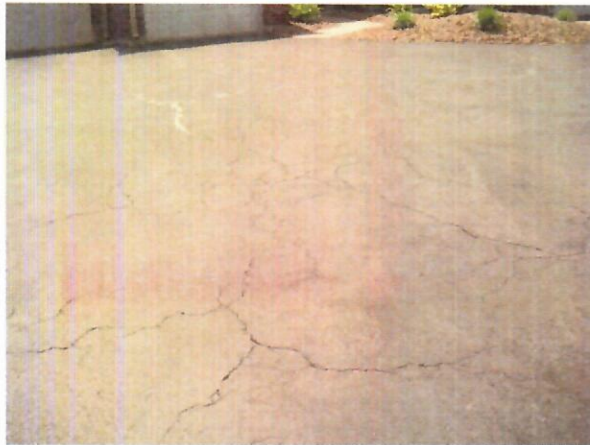
Example of Driveway Alligator Cracking

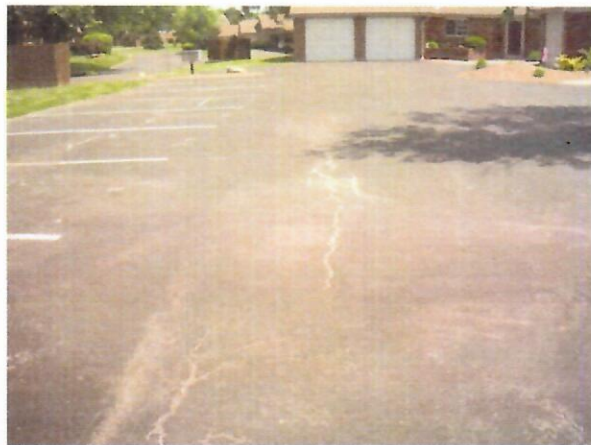
Here water is pooling in the center area causing small and accelerating deterioration

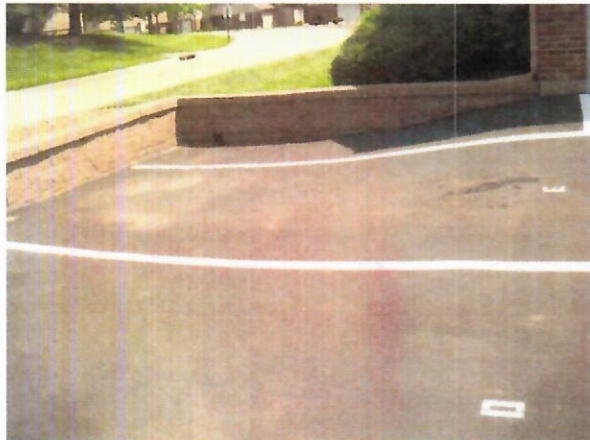
This driveways pitch has caused a depression
When repaired the water needs to be directed out.

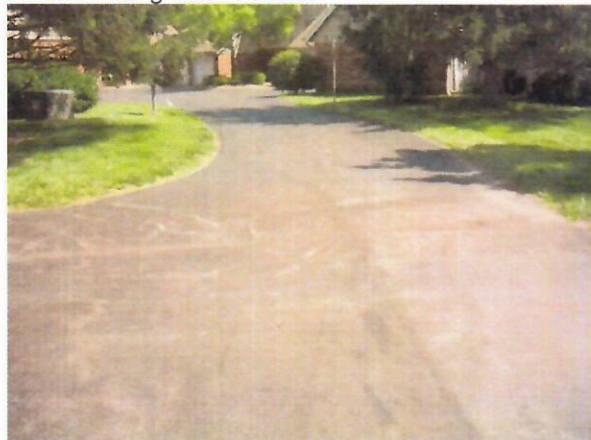
This section of entry drive is cracking

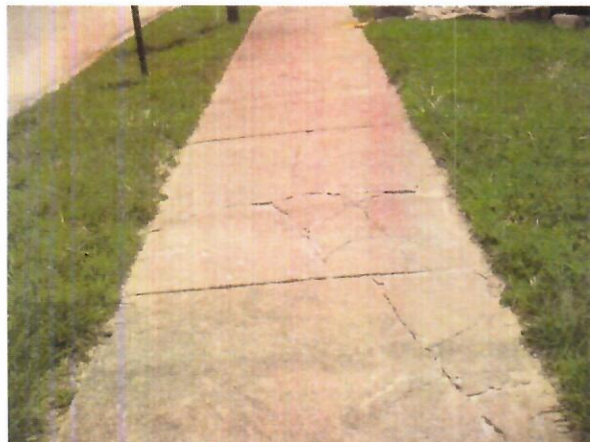
Significant Cracking

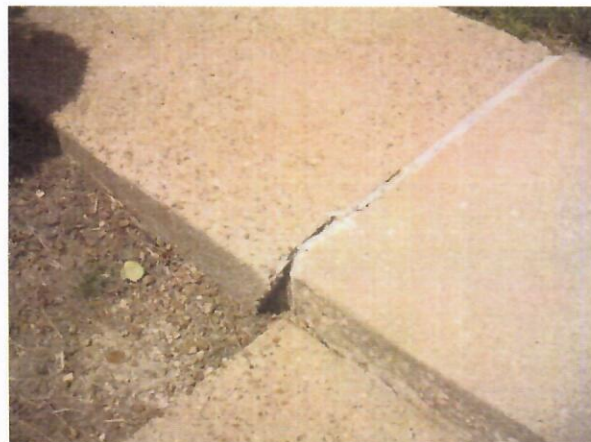
Expansion Joint failed walk seriously deflected

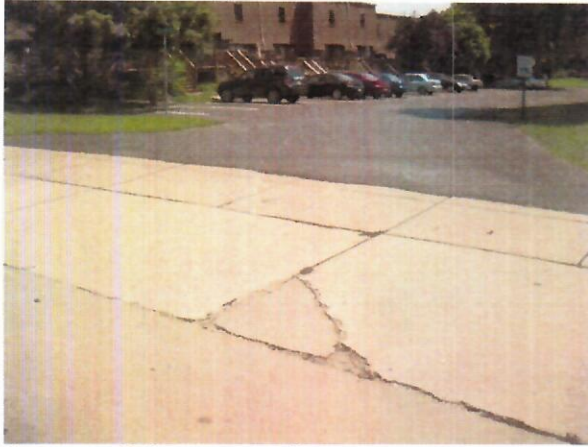
Concrete Driveway cracking

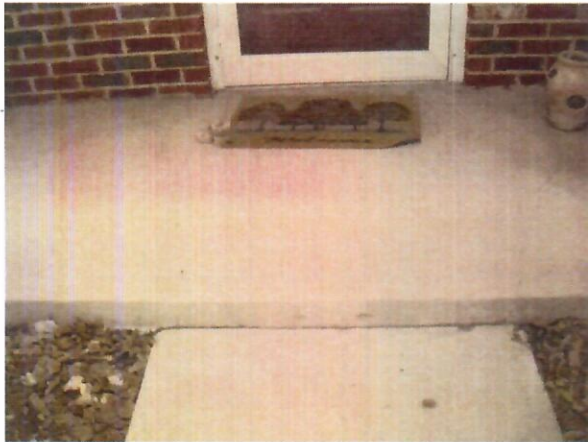
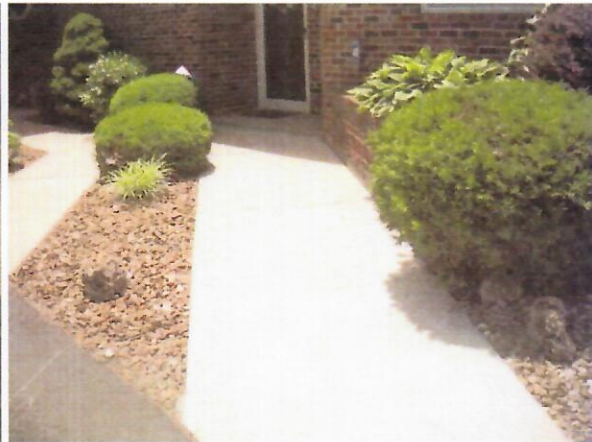
Typical Concrete cracks found in walks and stoops

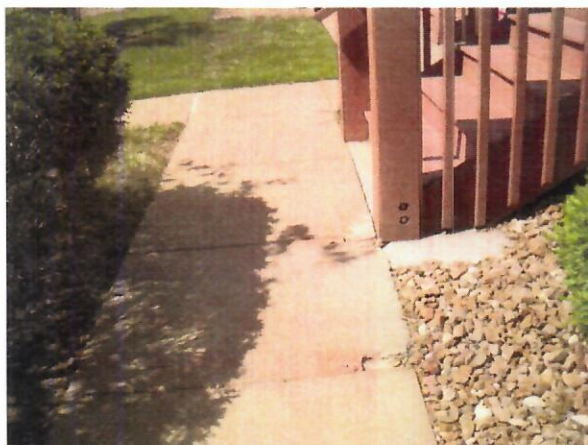
Walkway deterioration

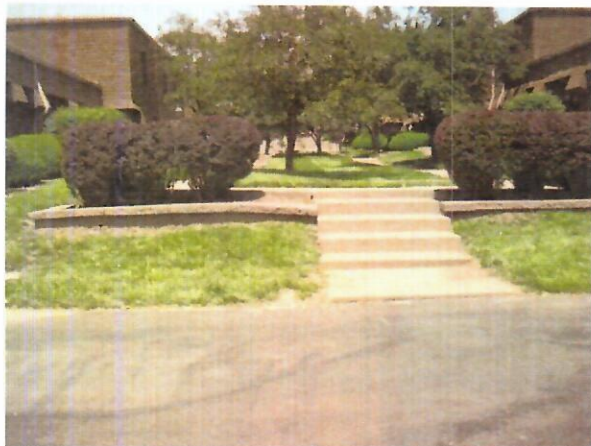
7. Unit Retaining Walls: There are several block retaining walls built in the community. Some protect driveways that are pitched down toward the street. Others protect the building walks. The walls were in most areas in satisfactory condition. There were some instances where shifting was observed and these areas should be monitored, and repaired if the condition worsens. **Work at the 3608-3614 area is planned at the expected cost of \$8,000 in 2017. This entry can also be found in "Special Construction", and will allow the extension of the useful life estimates for the other walks and walls for budgeting purposes.**

Sagging Wall should be repaired.

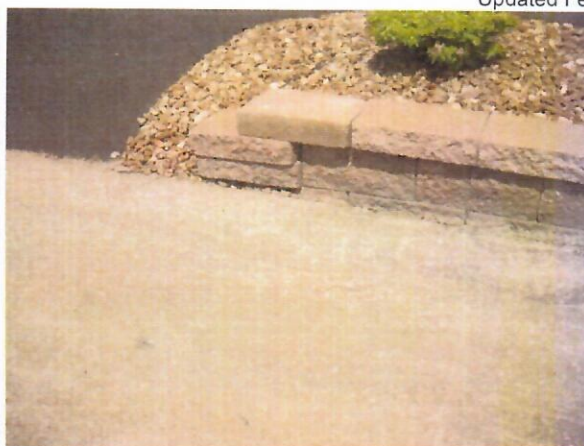
Monitor shifting blocks such as these.

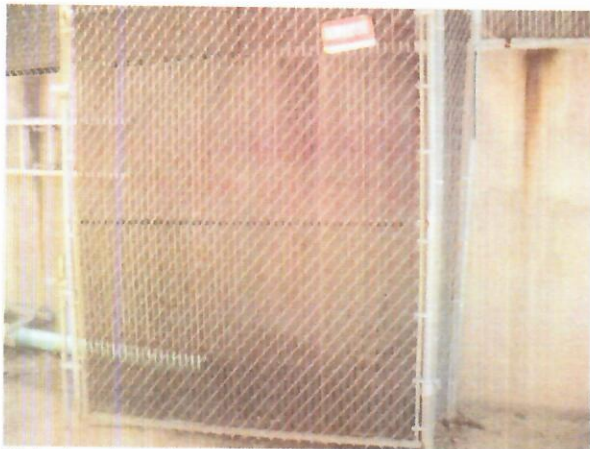
Gate in adequate condition.

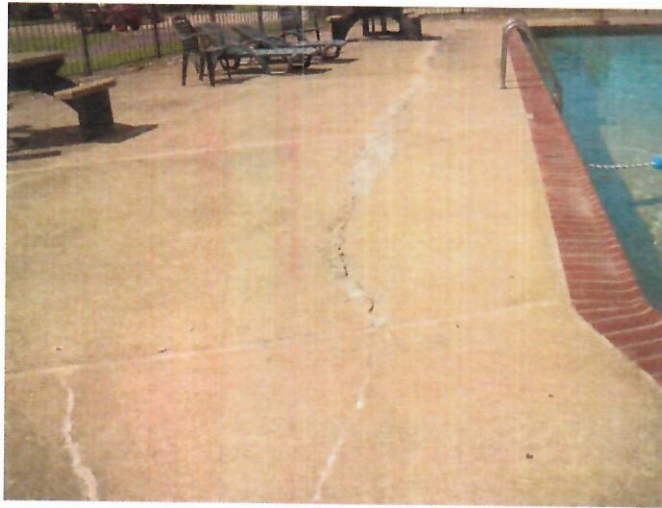
67. **Resurface Outdoor Pool Decks:** The outdoor pool deck is comprised of concrete. It was observed to have cracking in several areas. It appeared that caulking or other repairs were attempted and that those repairs failed. New repairs with proper products such as "sika-crete" and "sika-top" should be attempted prior to costly re-surfacing. **4 sections of the deck are to be replaced in 2015. Adjustments were made in the inventory for this work to be done.**
