Prepared for:
Spring Creek Condominiums
Florissant, Missouri
Project No. 5555-44.5

February 3, 2017
By Kipcon Great Lakes, LLC

Executive Summary

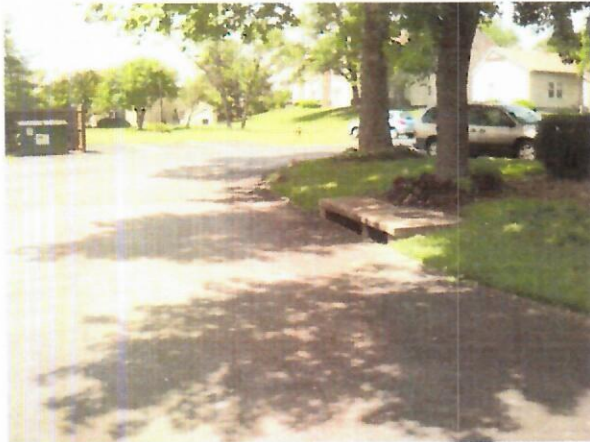
5. Storm Sewer Replacement: The roads of the development are equipped with open storm sewers for storm water drainage. For the Reserve Schedule a lump sum replacement/repair fund has been implemented and can be used to maintain the sewers as needed at the time of street repairs. The sewers themselves were observed to be in good condition. The sewers located on asphalt areas may require more attention to ensure water flow is properly maintained.

Storm sewer on asphalt road

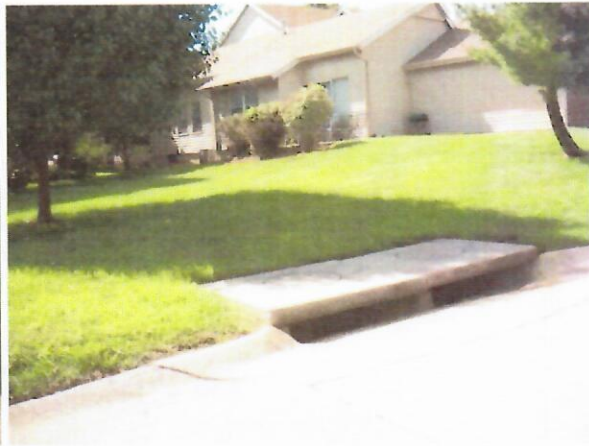
Storm sewer on pavement

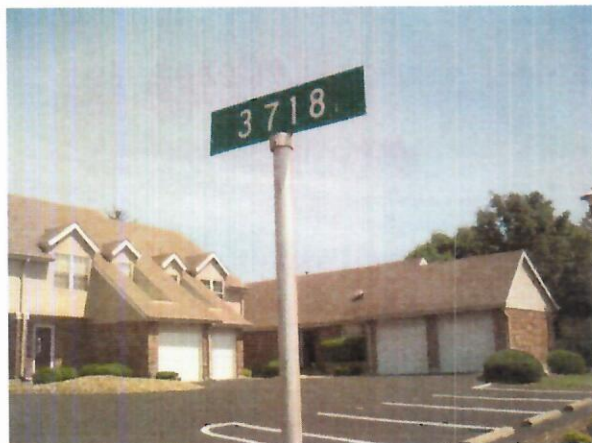
6. Wheel Stops: Some of the driveway parking area and auxiliary parking are equipped with wheel stops. Wheel stops generally are installed to prevent damage to curbs, landscaping or other features. Replacement may be required if they are damaged during other repair work, otherwise they have a long useful life.

Wheel Stops installed in driveway parking area

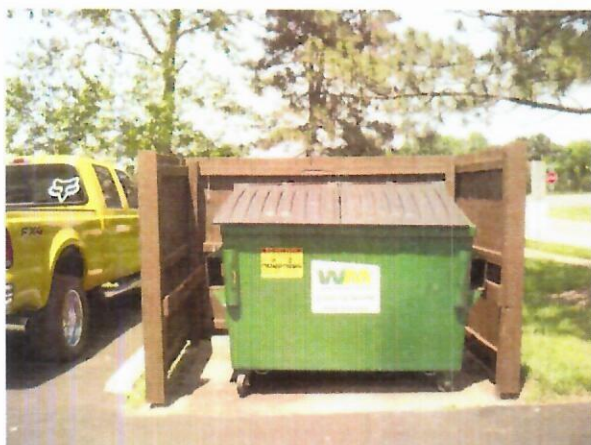
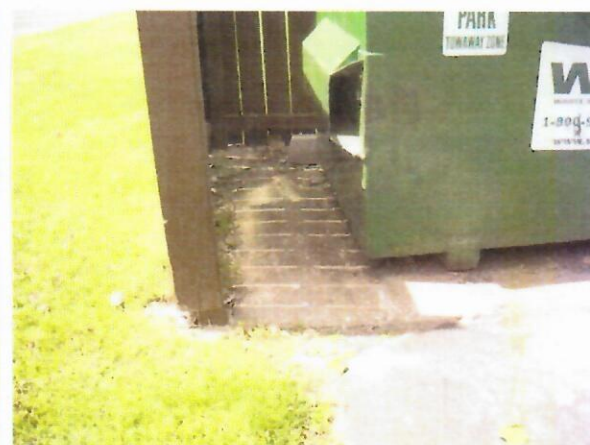
8. Dumpster Areas: There are nine (9) dumpster areas throughout the community, built with concrete pads and stockade type fencing. These areas are primarily maintained by the Association personnel and unless the pads deteriorate significantly should have extended useful lives. **In 2016 the pads at 3606 and 3610 were replaced. Based upon this 2 dumpster areas were separated in the inventory and their useful life restarted (8A) and the entry that listed 9 areas was reduced to the 7 remaining areas.**

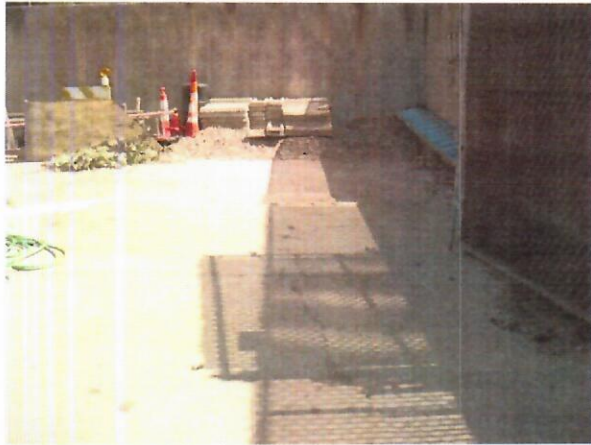
9. Clubhouse Yard and Rear Concrete: The Clubhouse maintenance yard area is constructed with concrete and there are concrete walks in the rear of the building leading to the recreation areas. These areas of concrete had significant cracks and are in need of some repairs. If not repaired the need to replace will be accelerated. **Work in this area was completed in 2015 both in the maintenance area and the walks behind the clubhouse. The inventory has been adjusted extending the useful life for these areas of concrete for this allowance.**

Maintenance Yard

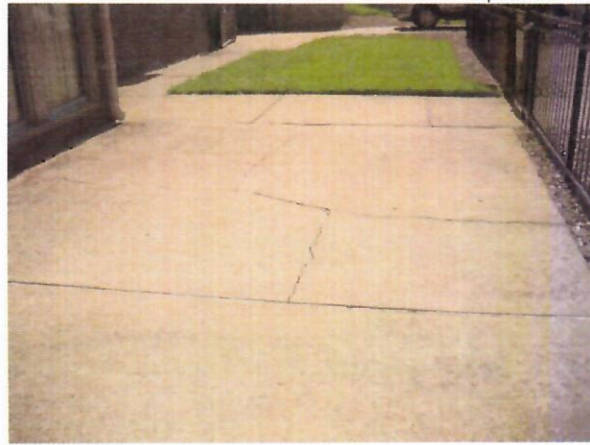
Rear Walkway

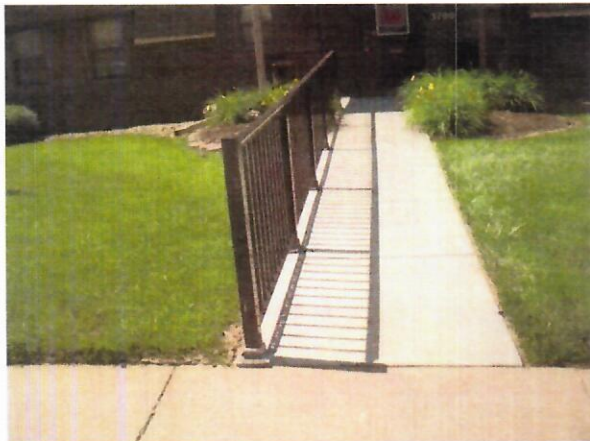
10. Clubhouse Front Entry and Side Concrete: The clubhouse is equipped with front entry walkways, that has been upgraded to be ADA accessible and is in very good condition. The side concrete and stairs up from the rear of the building to the front were also in better than average condition.

Newer Ramp for clubhouse front entry

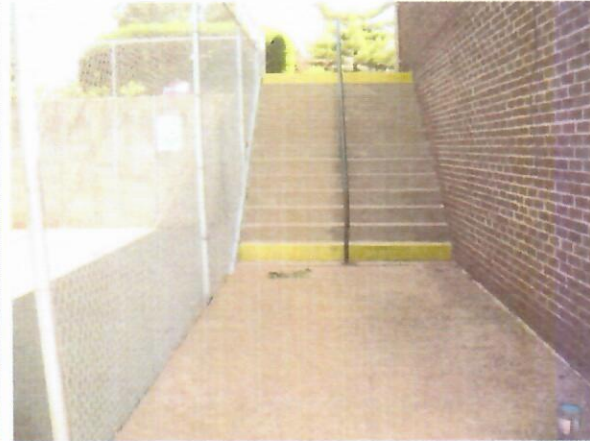
Side concrete and stairs

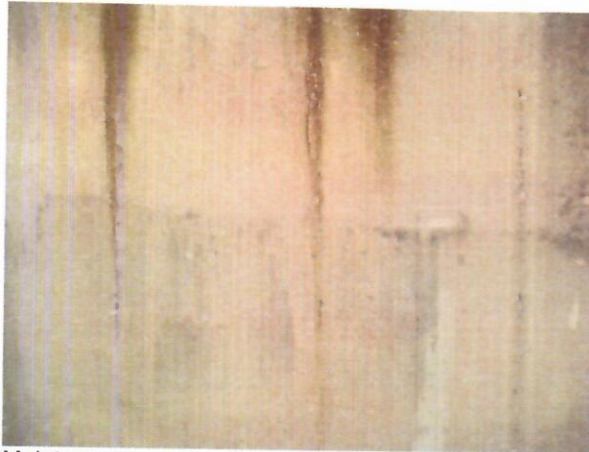
11. Clubhouse and Tennis Court Walls: The clubhouse yard and the tennis court areas are bordered with concrete walls. The walls were observed to be in fair condition. Evidence of deterioration was noted where water infiltration into the wall had caused damage to the metal ties and rebar and rust was leeching through the concrete. This is occurring primarily in the location of the attached fence posts due to the penetrations ion the concrete where they are attached. These require repairs that will prevent further water infiltration. The status quo will eventually cause the wall to begin to fail and patching sealing and related repairs should be undertaken to prevent a major expense.

Maintenance yard wall

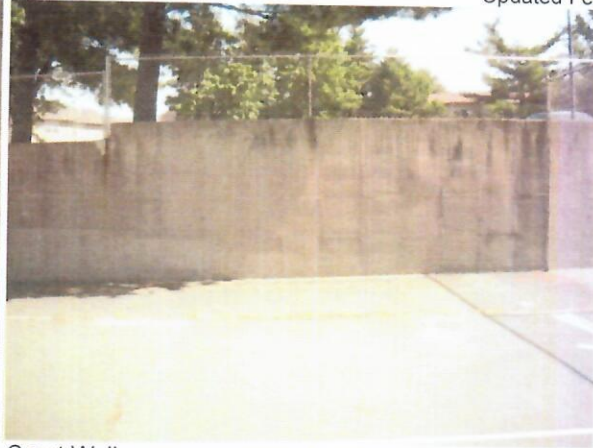
Tennis Court Wall

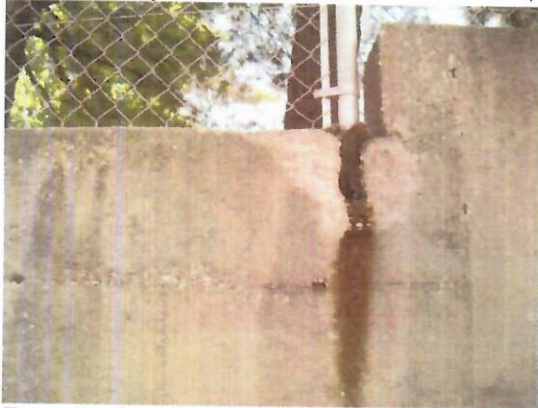
Example where fence post penetration is allowing water infiltration and damage.

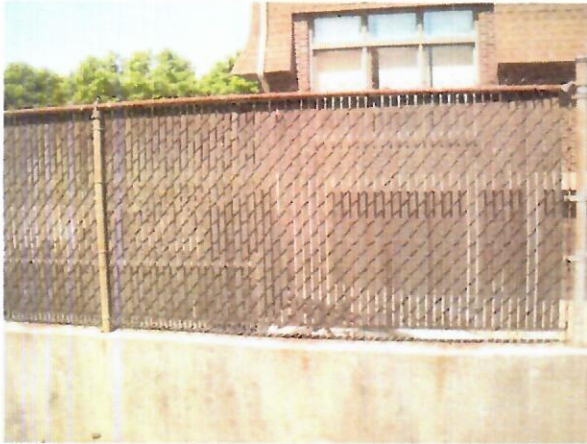
13. Concrete Wall Chain Link Fence: The top of the clubhouse and tennis court walls are protected by a short chain link fence installed into the top of the walls. The fence was in adequate condition other than the post footings that have been compromised and are allowing water to infiltrate the wall as discussed above in note 11. The tennis court fencing was observed to be in better than average condition, but as it was added to the tennis court wall the penetrations require maintenance.

Maintenance yard side wall

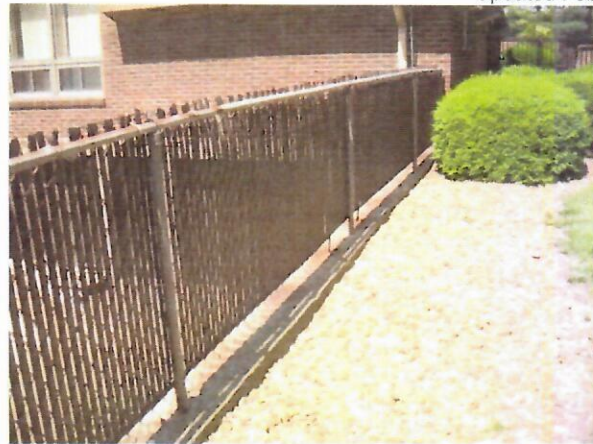
Extension to clubhouse front.

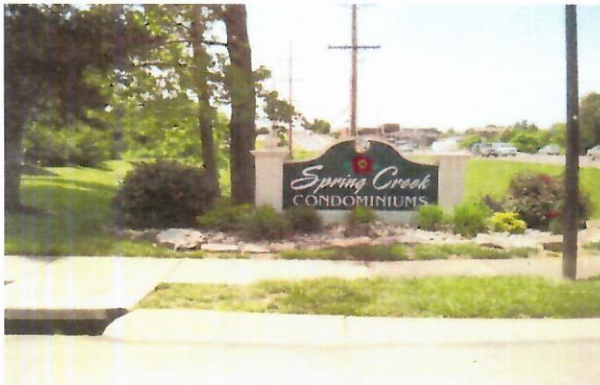
14. Entry Monument: There is an entry monument located at the main entry street into the Association. The monument was observed to be in good condition with well-maintained landscaping.

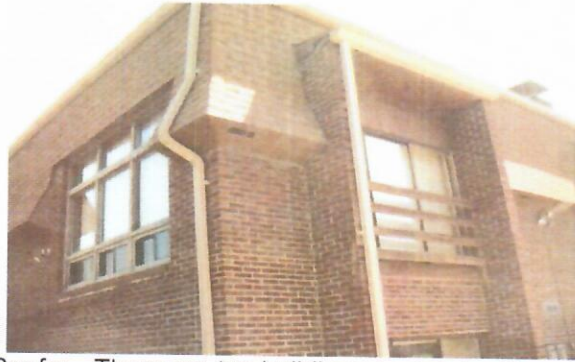
16. Club House Roofing: The club house roof is comprised of dimensional shingles and was last replaced after the hail storm event in 2001-02. The current roof was viewed from the ground and was observed to be slightly past 50% of its useful life. The building has a small shingled canopied roof at the front of the building.

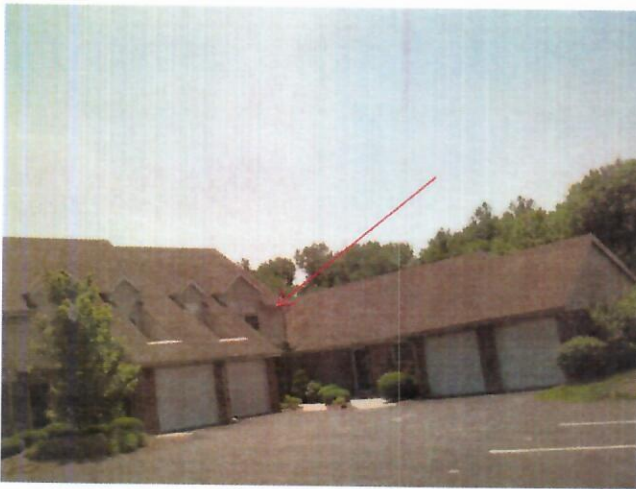
18. The 6-Unit Building Roofs: There are ten buildings containing 6- residential units. These roofs were also replaced after the storms of 2001. The shingles in the valleys of various garden style units may not have been properly weaved at the time of the replacement and have been or are scheduled for repair. The roofs are broken down into three phases for replacement beginning in 6 years.

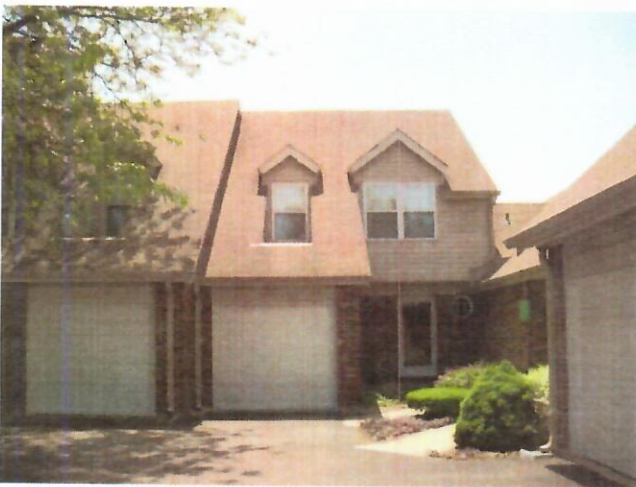
19. The 6-Unit Gutters and Downspouts: The gutters and downspouts were in adequate condition. They are scheduled in the same manner of the roofs for replacement.

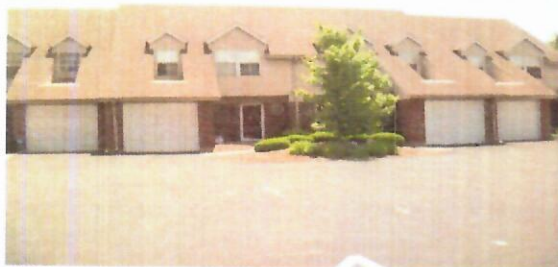
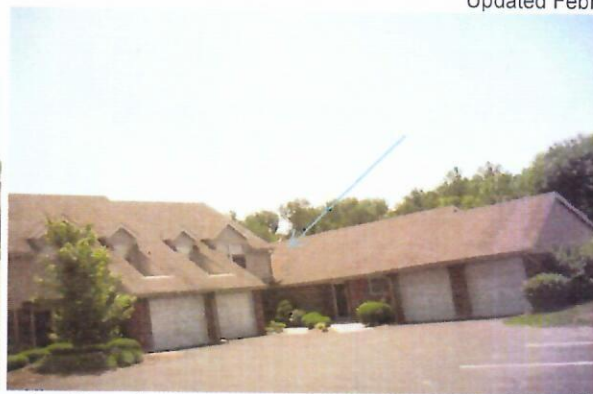
20. 8 Unit Roofs: There are six 8 Unit buildings in the community. The roofs were also replaced last in 2001-02. For budgeting purposes these have been divided into two phases for future replacement. The shingles observed were in a condition commensurate with their age.

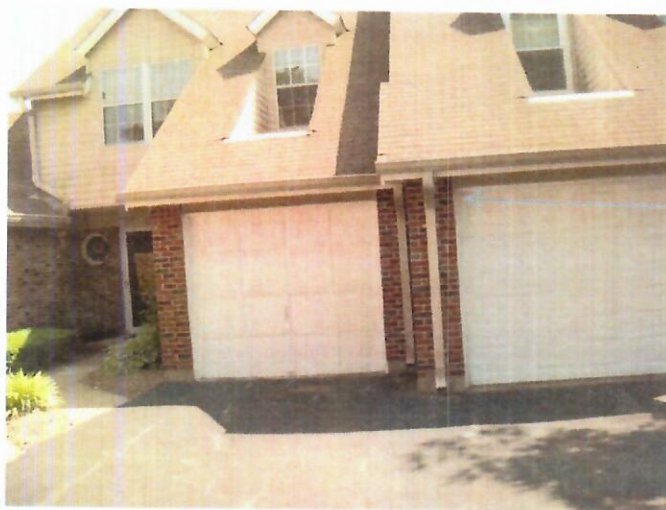
21. 8 Unit Downspouts and Gutters: The downspouts and gutters for the 8 Units buildings were observed to be in average condition and are scheduled for replacement with the roofs. Rusting downspouts at the elbows should be monitored

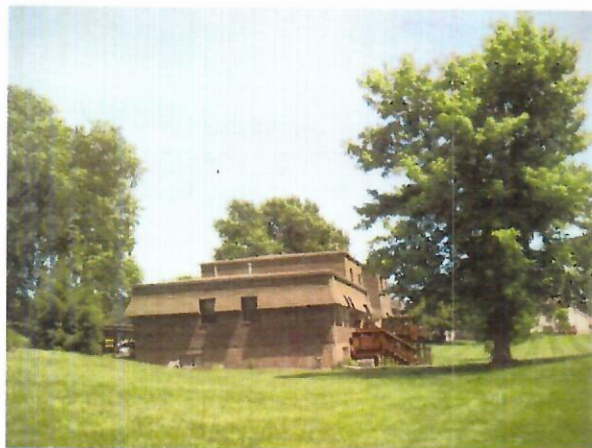
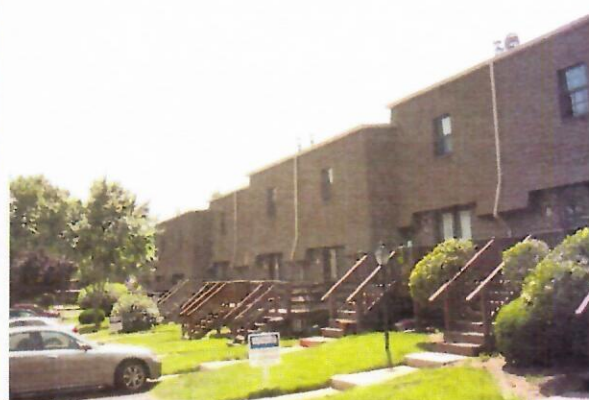
22. Original Building Roofs: There are two twin 10 unit original building and one additional 4 unit structure. These roofs are scheduled for replacement in a separate phase. These buildings in general do not have as steep a pitch as the newer models and as a result water run-off is not as efficient leading to shorter shingle life spans. Special attention should be placed upon correct flashing and freeze board installation at the time of replacement. The smaller building also has a car port roof constructed of metal decking.

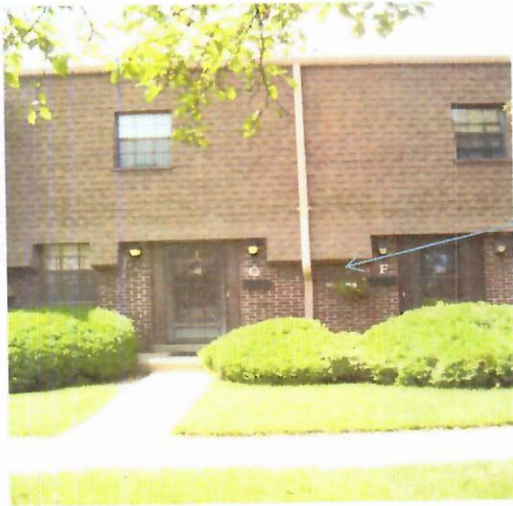
23. Original Building Gutters and Downspouts: The original buildings' gutters and downspouts are scheduled for replacement along with the roofs. The system should be carefully reviewed by an engineer prior to replacement to ensure proper calculations to lessen the potential storm water pooling due to the character of the roofs. Note should be taken regarding the elbows in the downspouts that were observed to be rusting.

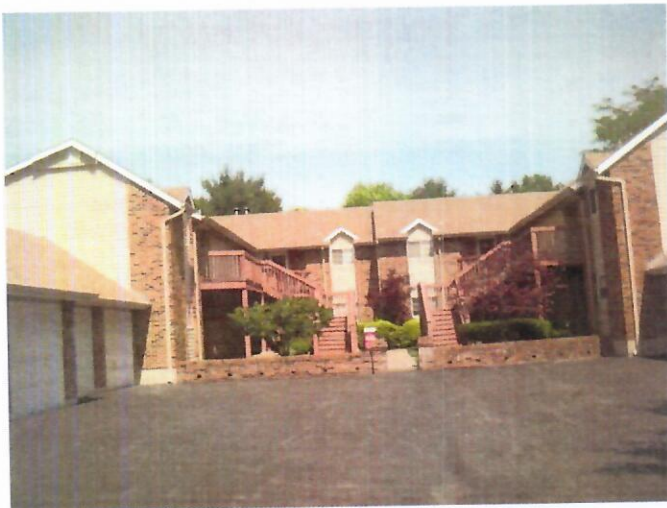
24. Stack Unit Buildings Roofs: There are three stack unit buildings. These have detached garage building. (Although the residential units and the garages abut). For the purposes of the phases for grouping roofing replacement the stack units with garages are scheduled together in one phase.
25. Stack Unit Gutters and Downspouts: The stack unit buildings were observed to have more than sufficient amounts of gutter and downspout which was in good condition based on the visual inspection.

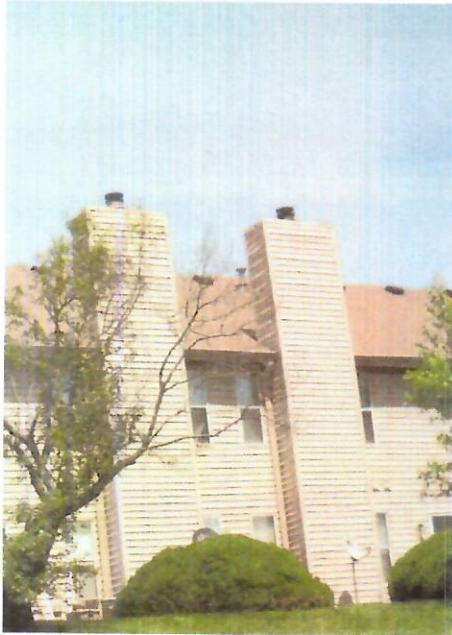
26. Chimney Caps: The roofs of the development are equipped with seventy-five (75) total chimney caps. The Association is preparing to replace the chaps. This can be done individually, in groups or as part of the roof replacement schedule. A separate calculation has been included based on the current estimate to replace. ***The chimney caps were replaced in 2013; the useful life of the component has been restarted.***

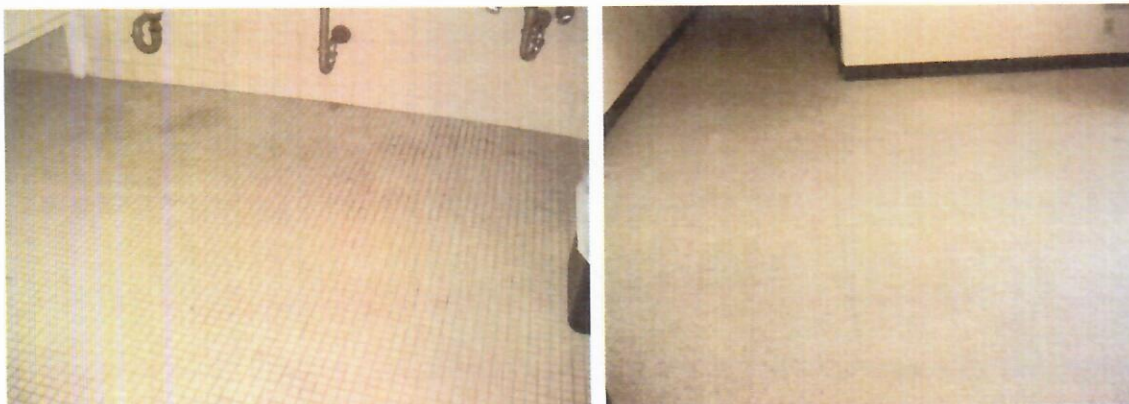
27. Clubhouse Tile Flooring: The clubhouse floors are covered with tile flooring in the entry vestibule, kitchen and in the locker room areas. Some discoloration in the tiles that was observed can be cleaned. There is also rubber tile flooring on the lower level appropriate for swimmers entering and exiting the locker room areas in good condition.

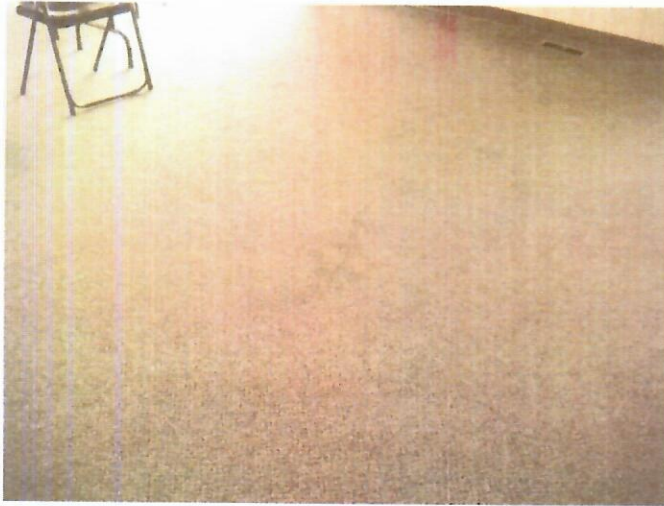
28. Clubhouse Carpeting: The main floor of the clubhouse is carpeted. The carpeting shows wear and tear and some staining. The useful life may be able to be extended with regular cleaning.

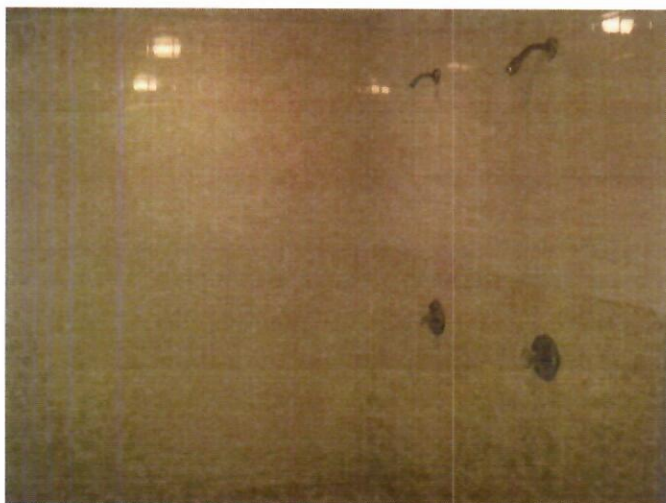
33. Locker Room and Restroom Fixtures: There are both men's and women's facilities in the clubhouse. These include showers, sinks and toilets. All were observed to be in1 adequate condition. A lump sum replacement recommendation has been placed in the schedule however; replacements can be installed on as needed basis.

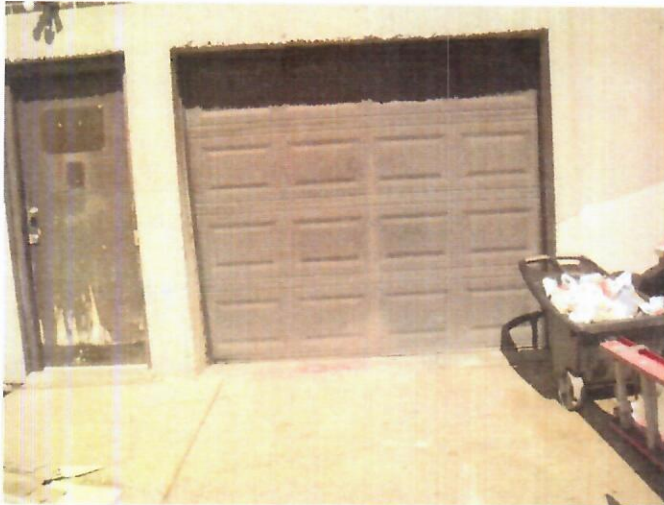
34. Overhead Doors: The lower level is equipped with two overhead doors for access from the maintenance yard area. One of the doors was set up in such way that it was not being used. The doors were in fair condition. If only one door is to be in use the permanent sealing and closure of the other could result in energy savings limiting heat and cooling loss at the area.

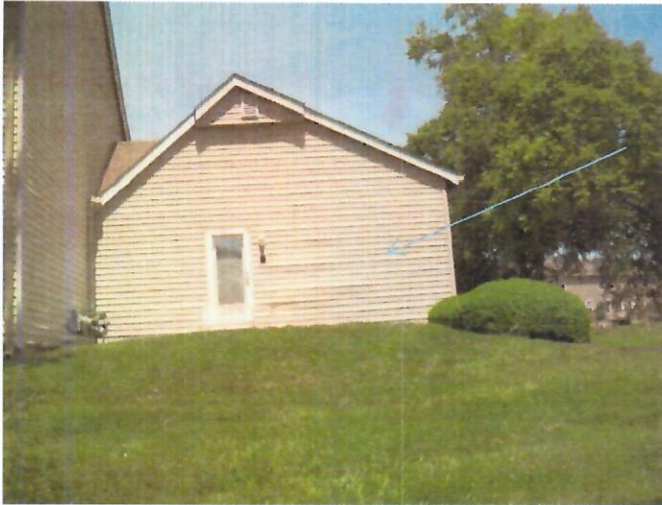
43. 6 Unit Buildings Siding: The ten 6 unit buildings have exteriors of vinyl siding and brick. For replacement purposes the materials have been separated and the building split into three phases. For the 6 unit buildings the ratio is set at approximately 80-20. The side and rear elevations are covered with siding as well as a portion of the front. The siding was replaced after the storm of 2001. Certain areas were noted to have defects.

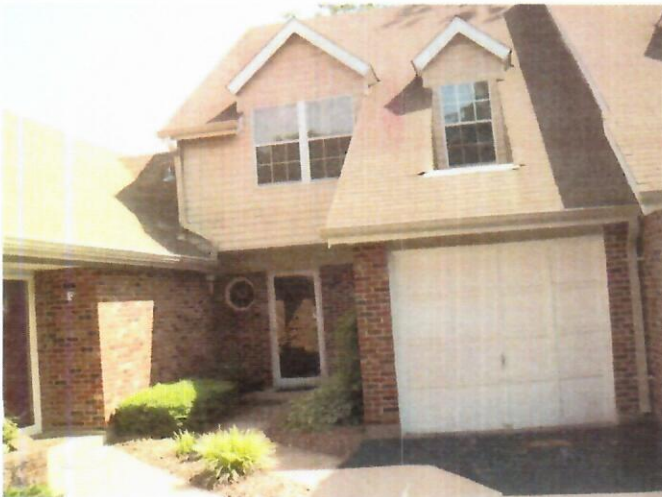
44. 6 Unit Facades Tuck Pointing: The front elevations and garage walls have brick installed. The masonry was observed in adequate condition and the schedule to review if pointing is necessary is set with the time the siding will be probably require replacement. **3 buildings 3608/3610 and 3614 were pointed in 2015. The phase I useful life has been slightly adjusted adding some estimated remaining useful life.**

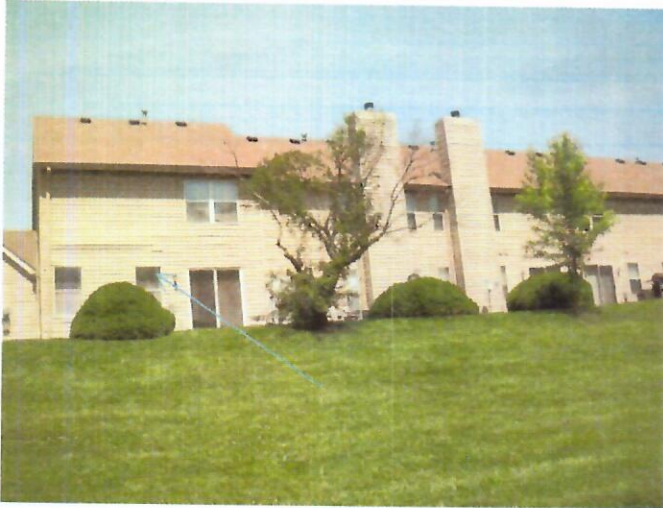
44. 8 Unit Facades Siding: The six 8 unit buildings have been divided into 2 phases for scheduled replacement. The age of all the siding is similar. There are some observable defects that should be repaired currently.

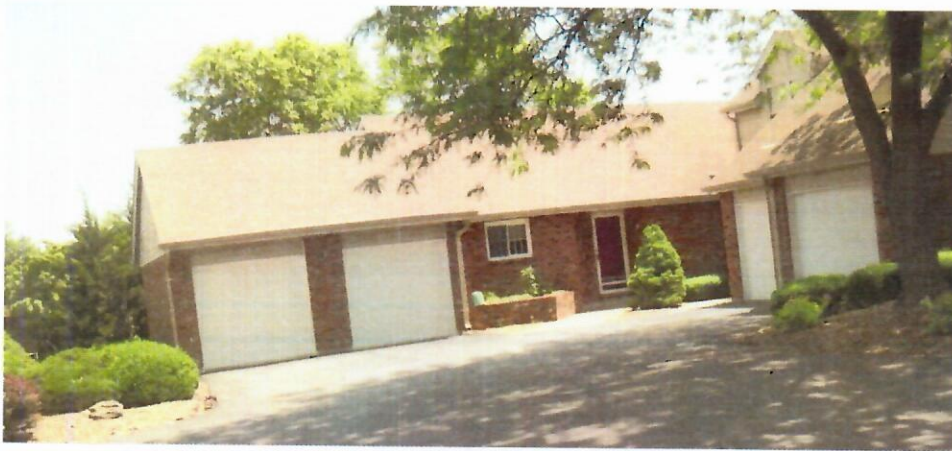
45. 8 Unit Tuck Pointing: In general the design of the front and side elevations are similar for the 8 unit buildings And the tuck pointing for these areas have been set to coincide with siding replacement.

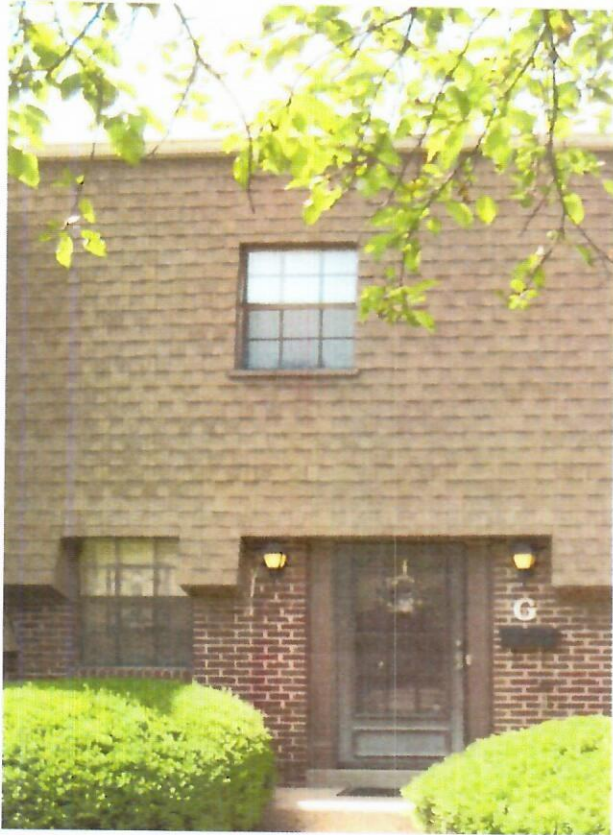
46. Original Building Façade, Shingles: The three original buildings were constructed with brick and mansard style shingled facades. The original buildings are phased together for replacement. The shingles reviewed were in adequate condition as per the schedule.

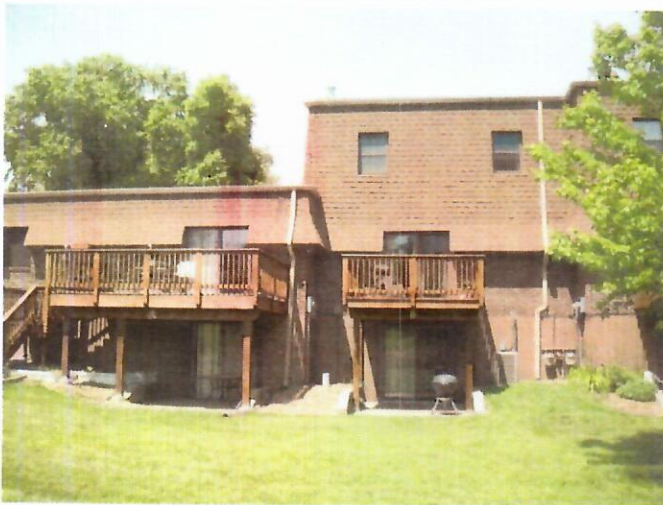
47. Original Building Façade Tuck Pointing: The lower front, rear and side elevations of these buildings have brick facades. The tuck pointing is phased on the same schedule as the shingle replacement.

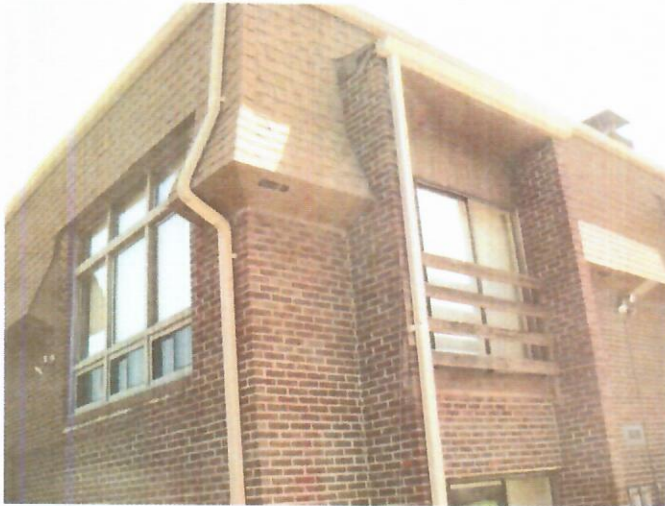
48. The Clubhouse Façade Shingles: The clubhouse was built with the same mansard style façade at the top of the building using shingles. These were observed to be in good condition. **There were repairs to the fascia made in 2015.**

49. The Clubhouse Façade Tuck Pointing: The remainder of the clubhouse is constructed of brick. The current condition of the mortar is satisfactory and can be done when the need arises.

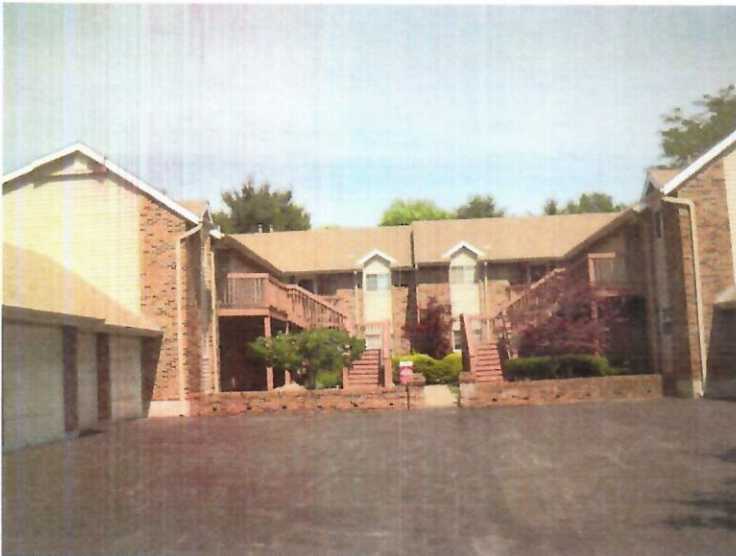
50. The Stack Units Façade Siding: The stack units are constructed with brick and siding fronts, siding on the rear elevations and brick facades for the garages. The three buildings have been grouped together for siding replacement and tuck pointing.

51. The Stack Units Tuck Pointing: The garage walls and front elevations are constructed with brick. There are also small retaining walls build across the front areas. The condition of the masonry was satisfactory however careful attention should be paid to the walls and entry door areas.

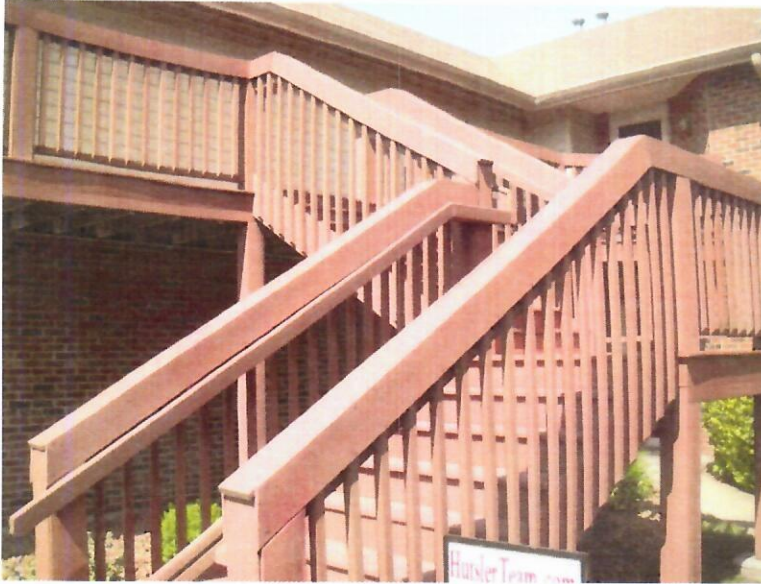
52. The Stack Units Wood Staircases: Each of the stack unit buildings are equipped with wood staircases for ingress and egress to the units. The staircases were observed to have areas of deterioration and repairs to any damaged risers, balusters, and railings as needed should be done. In addition sealing and staining regularly is recommended. Possible long term reduction of maintenance for these stairs and landings would be using maintenance free materials such as Trex for replacement.

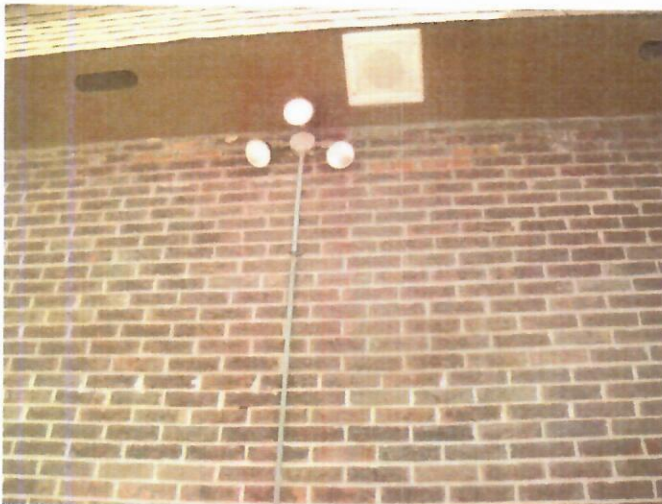
53. Clubhouse Exterior Spot Lights: The clubhouse is equipped with exterior spotlights in the rear of the building for safety particularly for evening pool activities, on the side stairway and at the maintenance yard. Timing mechanisms should be kept in good condition.

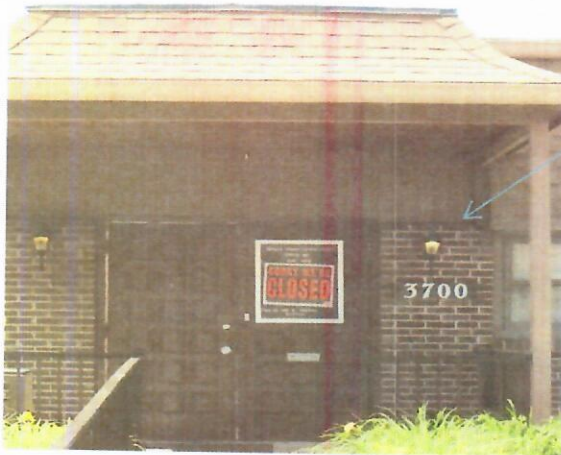
54. Clubhouse Exterior Lamps: There are two lamps mounted at the front entry to the building. These were in good condition at the time of the inspection. These were viewed to be on during daylight hours suggesting the timers need attention or adjustment.

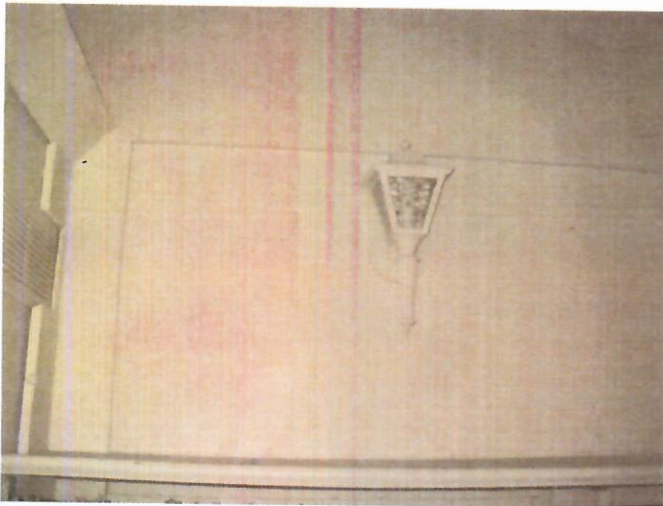
55. Interior Fixtures: The club house had various standard interior fixtures. When these become due for replacement higher efficiency fixtures and lights should be considered.

56. Interior Wall Mounted Lamps: There are five interior wall mounted lamps. Their uses appeared limited and are primarily decorative in nature. They may never require replacement.

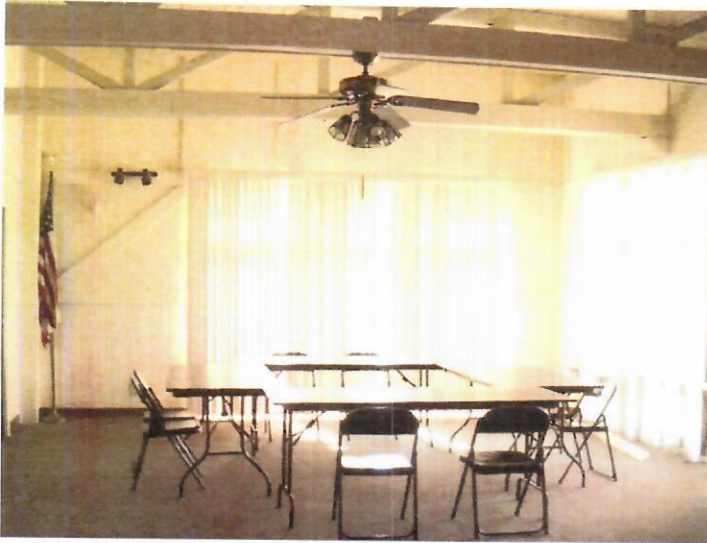
57. Fluorescent Lighting: There are several fluorescent lights installed in the club house, including the office and maintenance room. These were observed to be in good condition.

58. Ceiling Fan Fixtures: Three ceiling fan fixtures are installed in the club house. When replacement is required efficient lights and cost effective mechanisms should be reviewed.

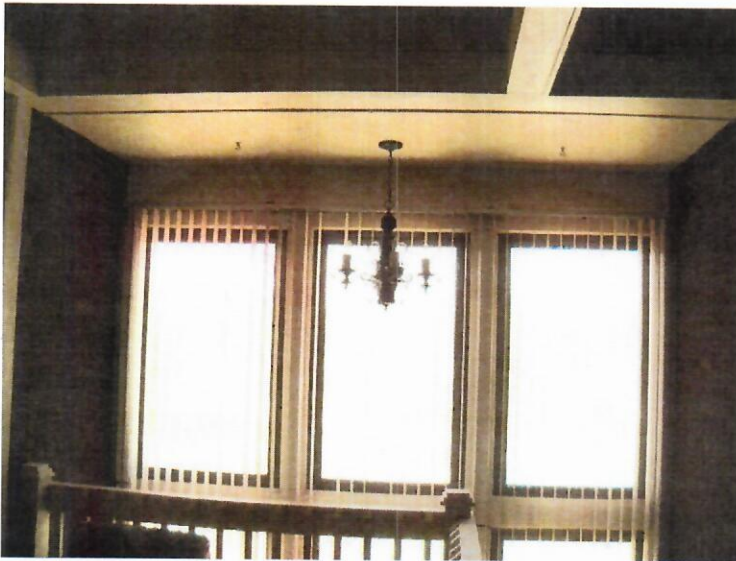
59. Chandelier: A chandelier is installed at the top of the staircase top the lower level of the club house. The condition was observed to be adequate.

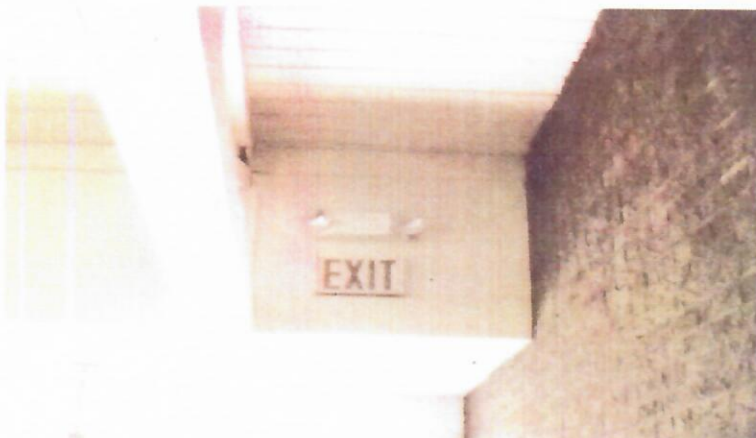
60. Emergency Lights: There are two emergency lights installed on the main floor of the club house. Review the lower level for additional lights as may be necessary.

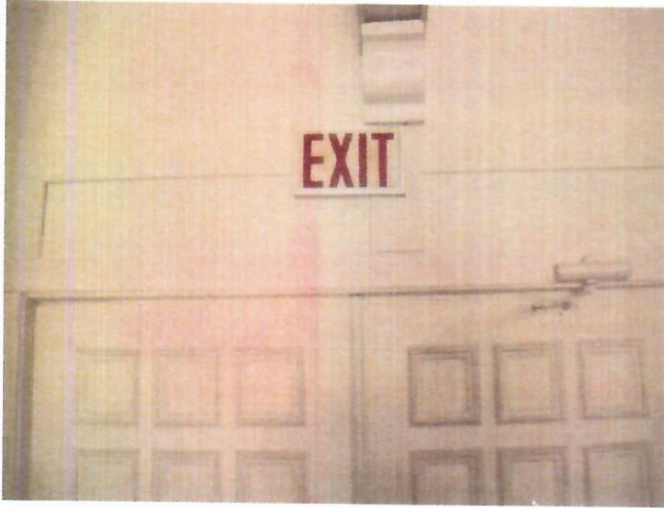
61. Exit Signs: Four exit signs were accounted for and observed to be in good condition and adequate for this building, at this time.

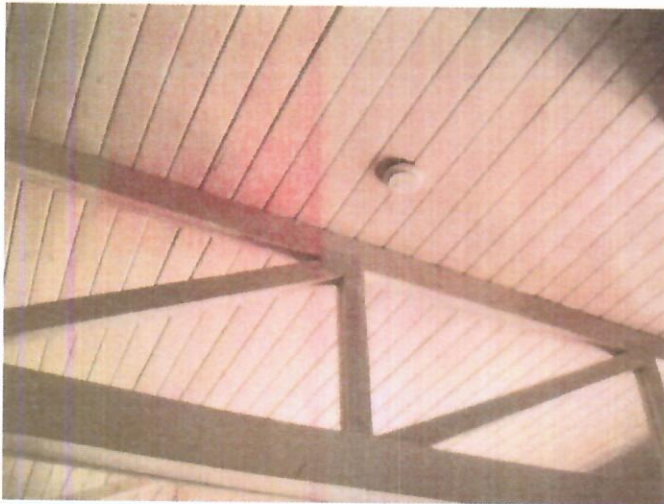
62. Smoke Detectors: Six smoke detectors are placed in the club house at appropriate locations. These should be changed as per manufacturer requirements and batteries changed each 6 months.

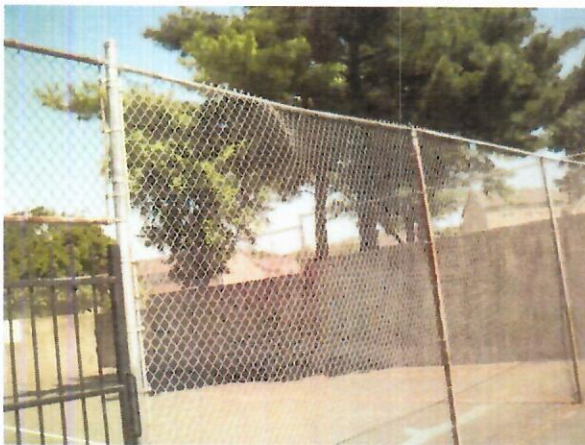
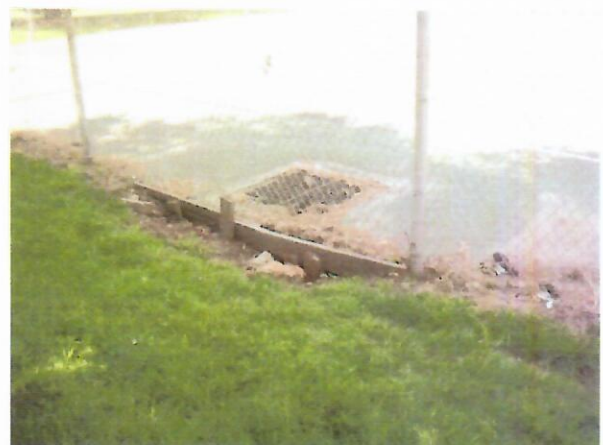
63. Tennis/Basketball Court Fence: The tennis and basketball courts are bordered with tall chain link fencing. The fencing is in varying stages of dis-repair including bad footings, broke links and areas of significant rust. Plans to replace fence in the near future should be considered. The basketball fencing along the new clubhouse staircase was in good condition. Issues with the tennis court drainage should be reviewed prior to any installation of new fencing.

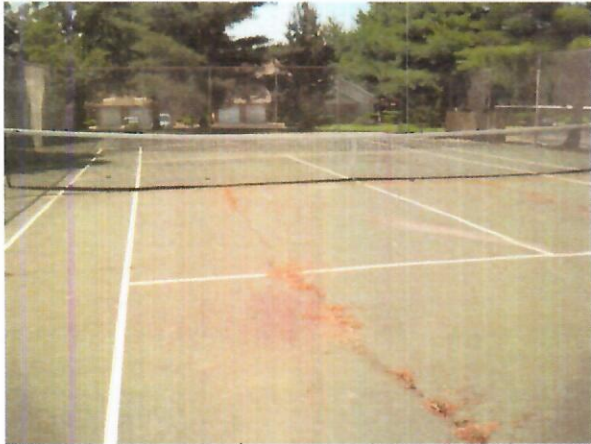
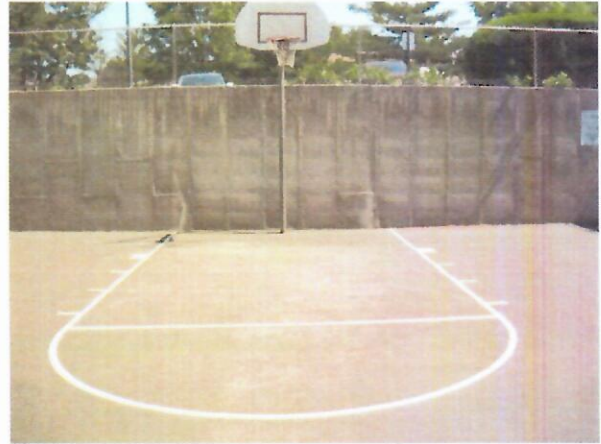
64. Tennis/Basketball Court Resurfacing: The continued use of the tennis court for its designed purpose will require a re-surfacing. The court has significant cracks, is poorly pitched for drainage and is deteriorating. Deterioration will accelerate if repairs are not soon undertaken. **The tennis courts were resurfaced in 2016 at the cost of \$9,985 and the useful restarted and the future cost adjusted.**

The basketball court remains in adequate condition at the present time.

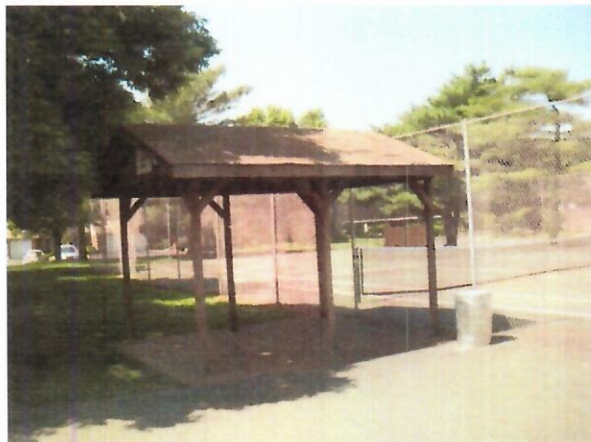
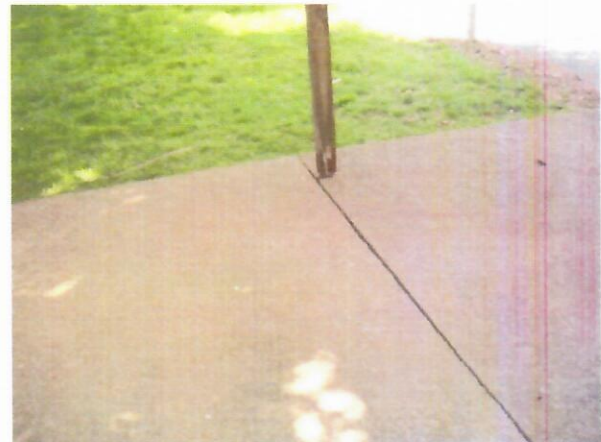
65. Gazebo: There is a gazebo shelter at the tennis court area. It was observed to be in fair condition and the support posts and footings should be monitored to ensure the post is sitting square on the footing.

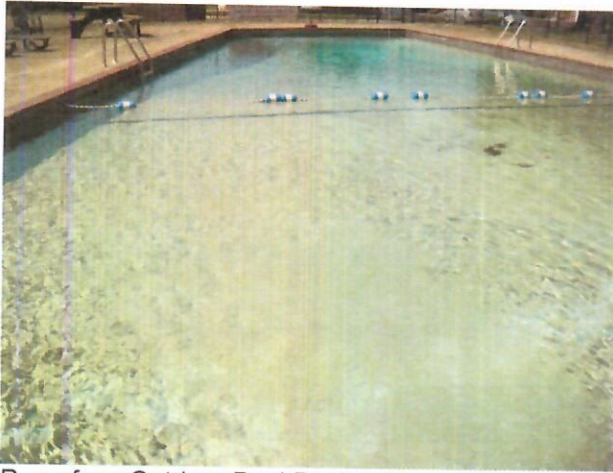
66. Repair/Paint Outdoor Pool: The Association maintains an outdoor swimming pool. The pool requires structural repairs and repainting regularly, so it has been added to the reserves. At the time of the inspection the pool lining was observed to be satisfactory, and no leaks were reported, For an actual inspection the water would have to be drained. Pool maintenance agreements should be maintained as the most cost effective method to keep up with the liner. **The Pool was resurfaced in 2014 at the cost of 26,571. This was adjusted for in the inventory.**

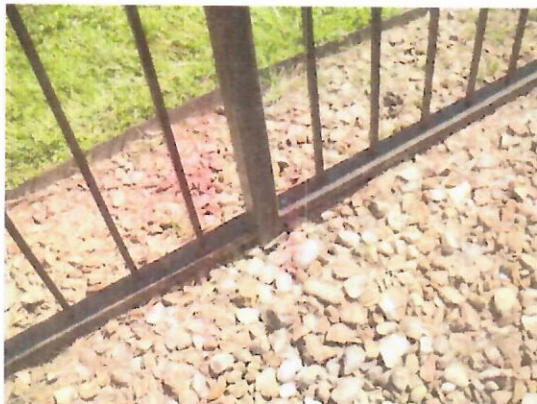
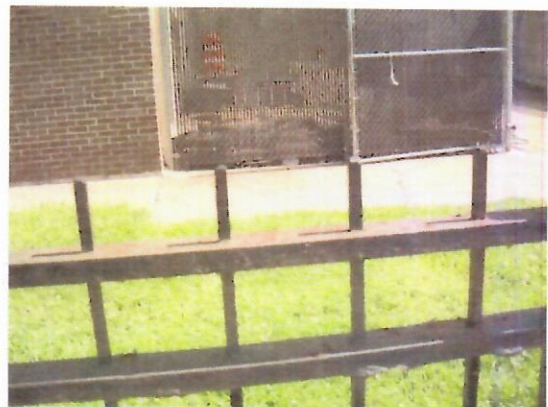
68. **Pool Fence:** The current wrought iron pool fence has areas of rust and may not be tall enough to stop trespassers onto the property. The Association is considering a more suitable replacement. In the event the fence is not replaced it should have the areas of rust grinded and the entire fence painted. ***The pool fence was replaced in 2013 with a new 6ft "non-climbable" system.***

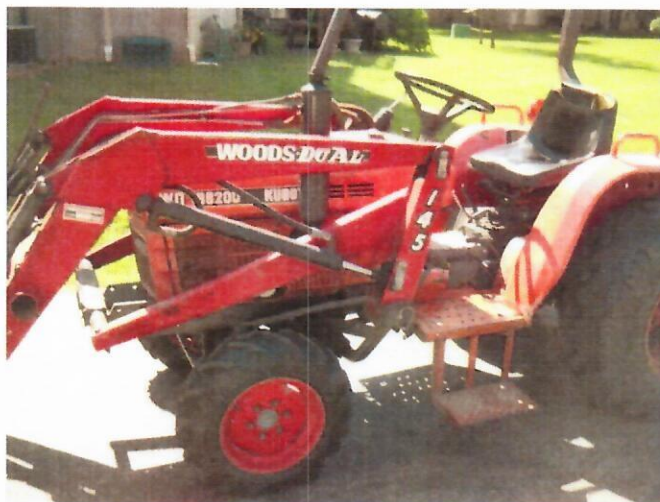
72. Tractor: The Association owns a Kubota Tractor that is nearing the end of its useful life. The manufacturer has various similar styles and models, therefore the replacement cost here is merely for suggested cost of a possible replacement model. **A new tractor is in the process of being or will have been purchased by the time of the issuance of this report. The Association has contracted to pay \$17,539.00 for the new vehicle and finance it over 60 months at the cost of \$3504.00 per year.**

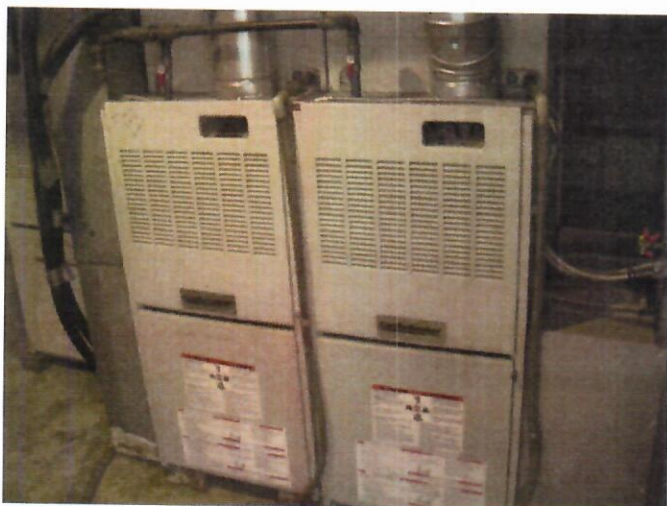
73. Furnaces: The clubhouse is equipped with three (3) comfort maker furnaces that were replaced in 1999-2000. They were observed to be in good condition and if properly maintained will last at least an additional 8 years.

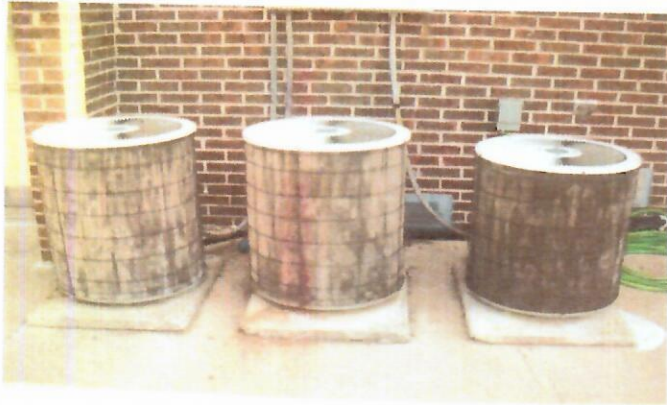
74. Condensers: The furnaces operate in tandem with three (3) Comfort Maker condensers set on concrete slabs. The condensers due to their location at the rear of the clubhouse have suffered wear and tear and should be monitored, and covered during the winter.

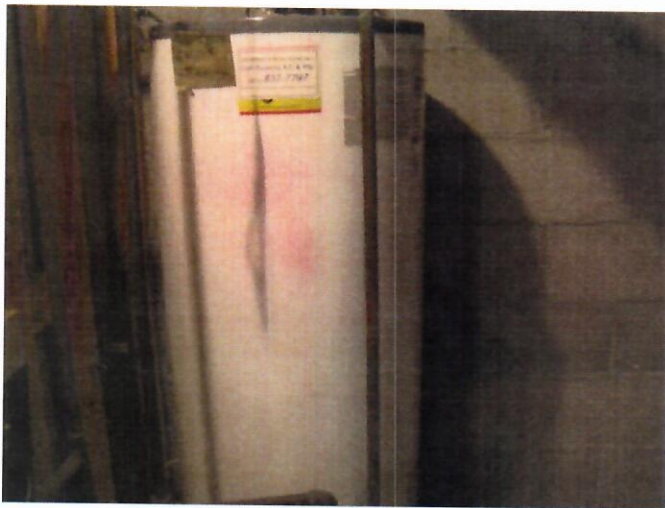
75. Domestic Hot Water Heater: The clubhouse obtains hot water from a 50 gallon Ruud gas fired hot water heater. The unit was installed in 1998 and no operating deficiencies were reported.
