Prepared for:
Spring Creek Condominiums
Florissant, Missouri
Project No. 5555-44.5

February 3, 2017
By Kipcon Great Lakes, LLC

Executive Summary

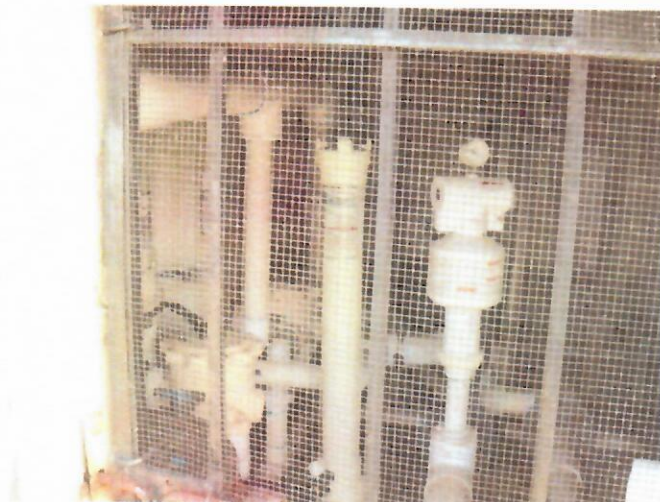
76. Pool Pumps and Filters: The pool pumps and filters are located at the pool pump house as described above. The pumps and filters were not physically tested but visually appeared in adequate condition. ***A new pool pump was installed in 2014; the component inventory reflects this purchase, in both useful life and cost reduction.***
